# **Water pollution report: Beverley Brook at Palewell Common & Fields**

**May 2025**

# Beverley Brook at Palewell Common & Fields

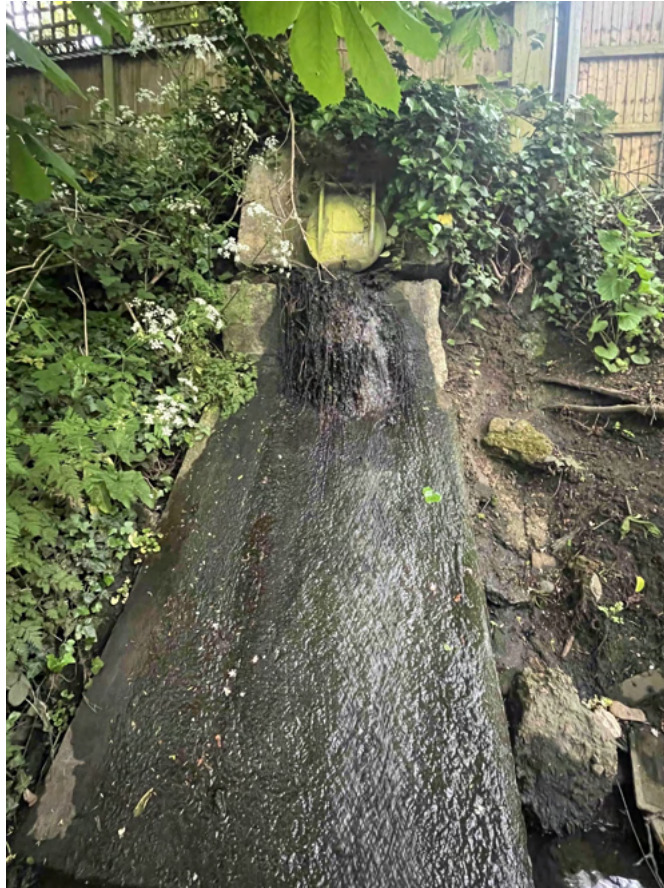
- These polluting outfalls are the result of sewage or utility waste pipes having been mis-connected to surface water drains, which then pour polluting waste water directly into Beverley Brook. The outfalls are scored using a guide developed by ZSL (Figure 2), which rates the visual and aesthetic impact of each outfall. Those scoring over 10 are reported for urgent attention to Thames Water, and if the outfall is connected to a private residence or Council estate, it is referred to the Environment Agency (see Figure 3a). Those outfalls scoring between 4 - 9 are recorded and may be investigated further (see Figure 3b).

**Figure 3a. Most polluting sewage outfall BEVB0011 (score = 10).**

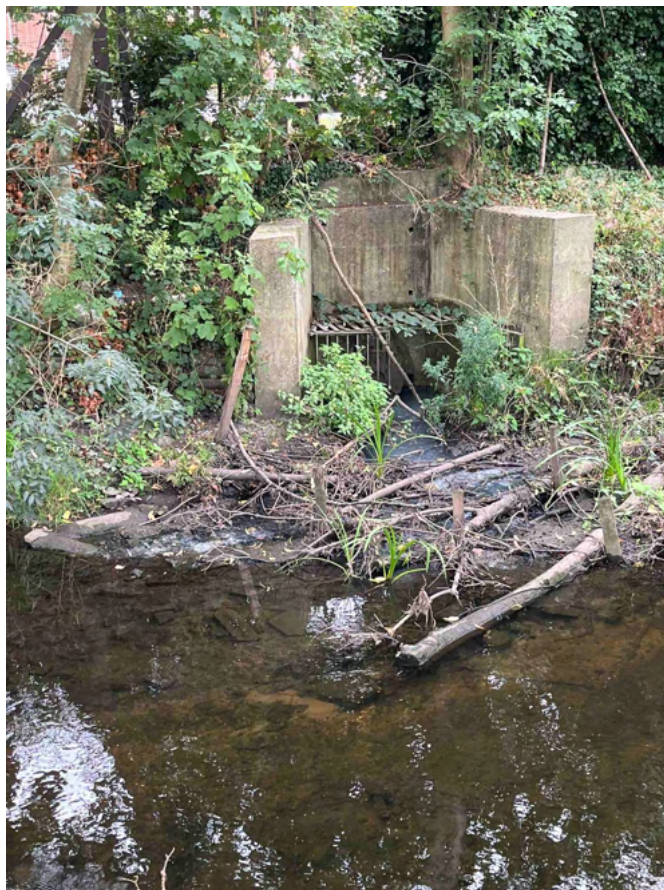
**Figure 3b. Example of a utilities polluting outfall. Lennox Estate BEVB0025 (score = 4).**

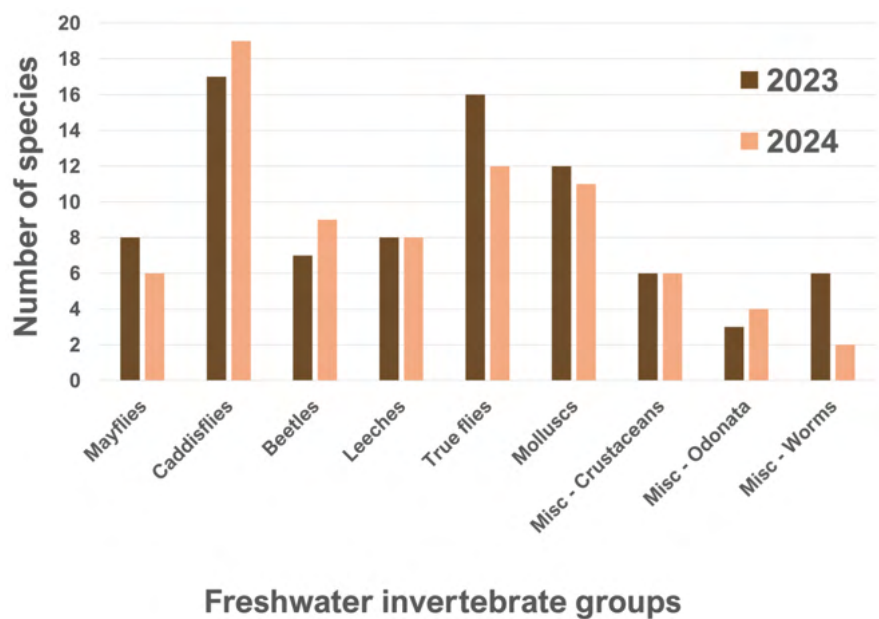
- SmartRivers, a program monitoring river health by the charity WildFish, identifies freshwater invertebrate species to infer water and habitat quality. As part of a Rewild London Fund grant to restore this same stretch of Beverley Brook, the conservation team at Barnes Common charity have surveyed freshwater invertebrates at five sample sites. Baseline survey data before restoration work took place, revealed a high abundance of pollution and stress tolerant freshwater species. Despite substantial in channel and bank restoration work having been completed to improve habitat diversity, there has been no significant change in diversity of freshwater invertebrate groups (Figure 5).

Figure 5. SmartRivers freshwater invertebrate diversity. Pre- (2023) and post- (2024) restoration.
